2014 BRIDGE INSPECTION REPORT

STRUCTURE NO. 8004

GAINSBORO ROAD (2ND STREET)
OVER
NS RAILWAY AND SHENANDOAH AVENUE

30 SEPTEMBER 2014
AND
16 OCTOBER 2014

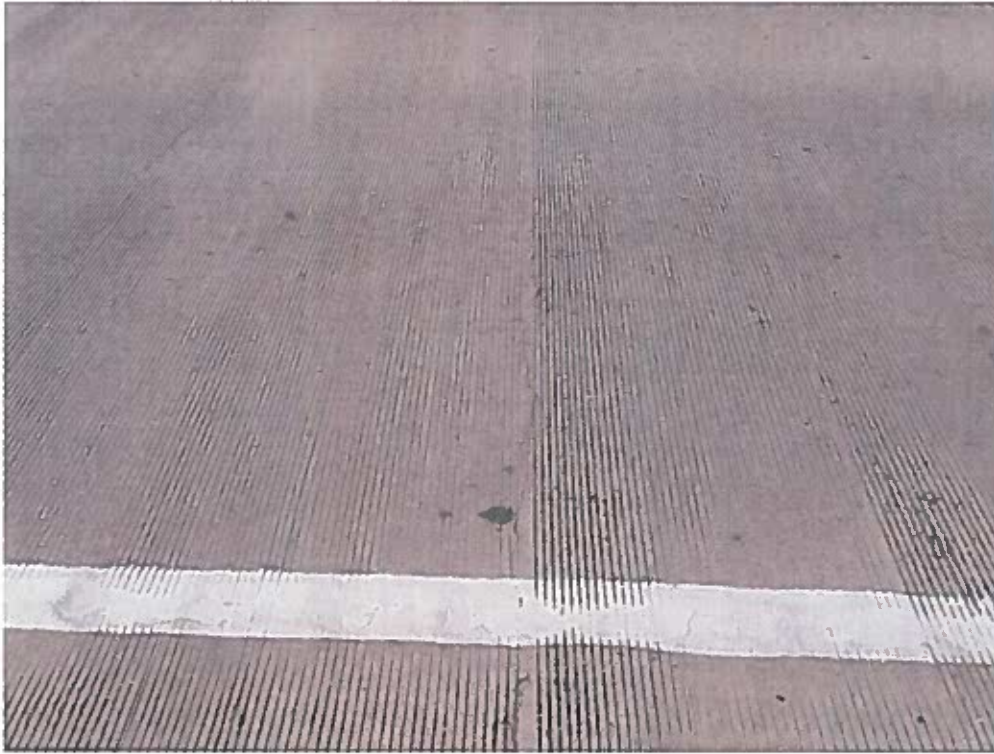
Areas of hairline map cracking throughout. Light chipping (up to 1/2" deep) in edge of deck along expansion joint at both abutments. Hairline cracking in all spans as follows (Photo 1):

PHOTO 1 - TYPICAL CONDITION OF TOP OF DECK. NOTE CRACKING.

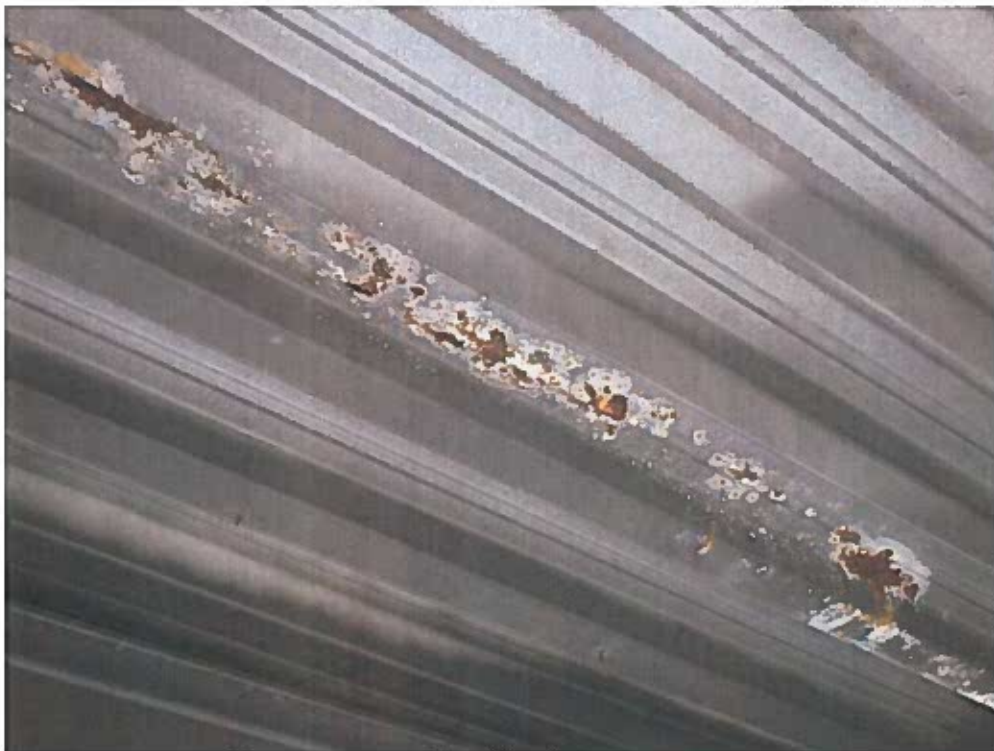
Stay-in-place forms. Light areas of rust, moisture seepage, and section loss noted throughout (Photo 2).

PHOTO 2 - RUST AND SECTION LOSS TO STAY-IN-PLACE FORM.

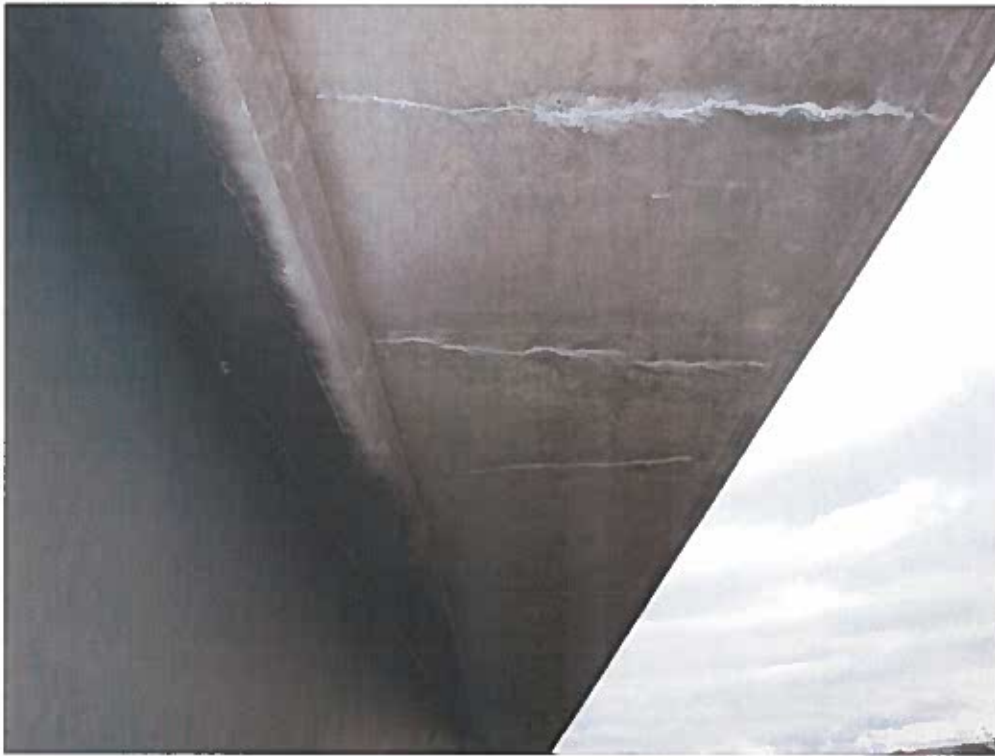
Transverse hairline cracking with efflorescence noted in both deck overhangs (Photo 3).

PHOTO 3 - TYPICAL CRACKING WITH EFFLORESCENCE IN DECK OVERHANG.

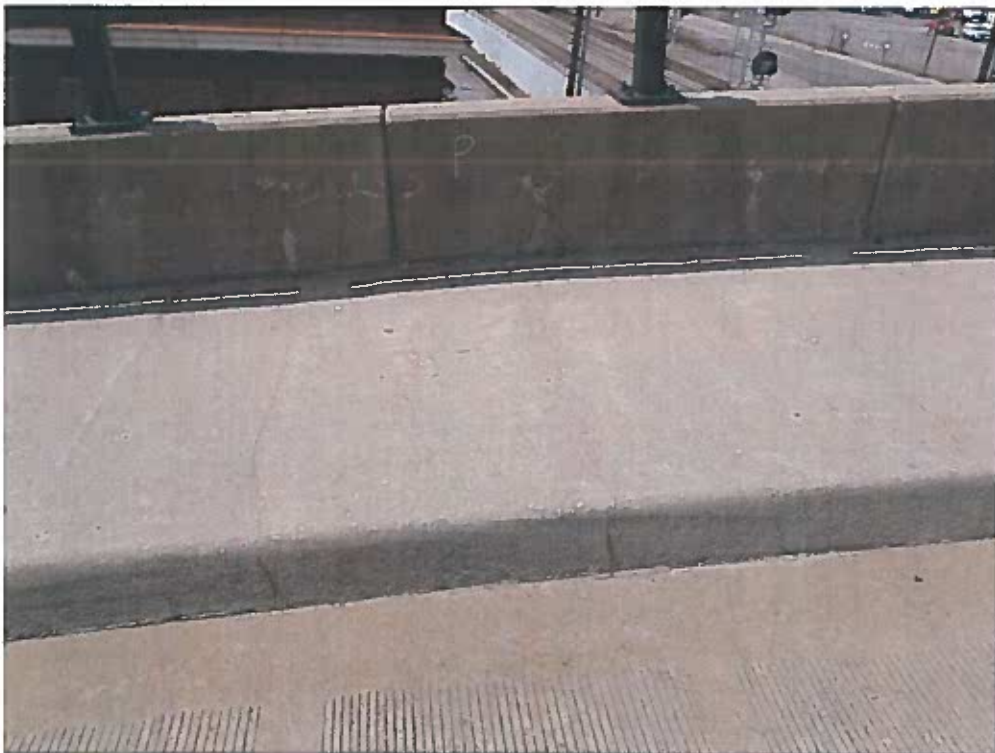
Vertical hairline cracking throughout (Photo 4). Light traffic damage noted along curbs.

Transverse hairline cracks in both sidewalks (Photo 4): 170 in west side and 140 in east side. 280 LF of longitudinal hairline cracks and light map cracking in west sidewalk.

PHOTO 4 - TYPICAL CRACKING IN CURB, SIDEWALK, AND PARAPET.

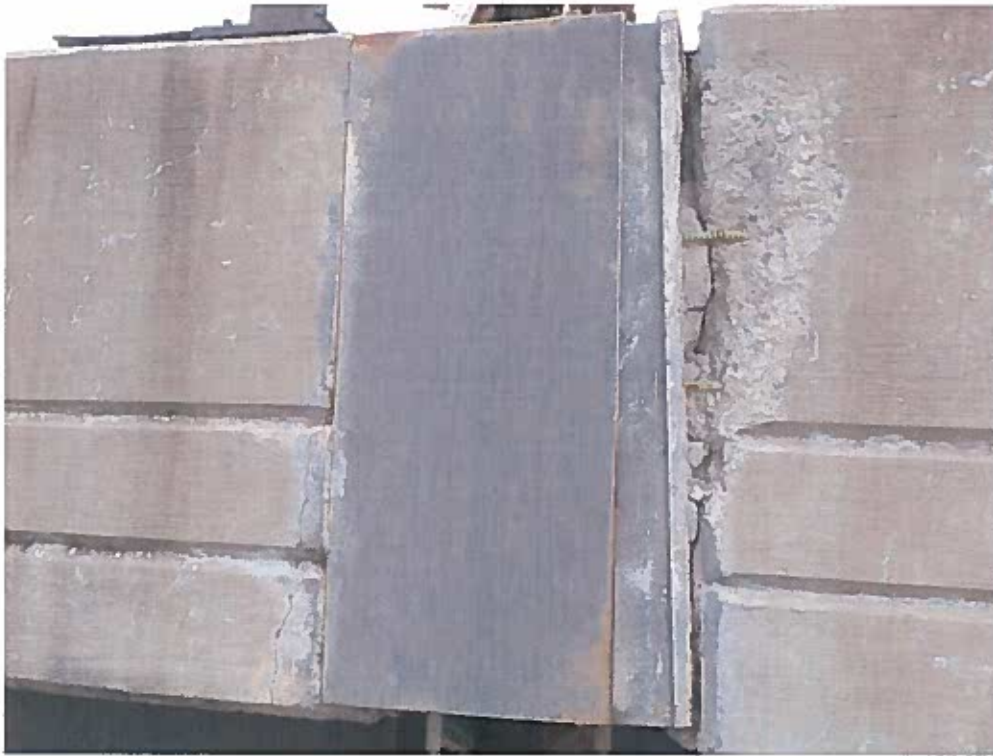
Full height vertical hairline cracks with efflorescence on each face of both parapets (Photo 4). Light horizontal hairline cracking at parapet construction joints. 4 SF spall/delamination (up to 3" deep) with exposed reinforcing steel in exterior face of west parapet at Pier 4 (Photo 5). Spall extends into back of sidewalk. 0.5 SF delamination on exterior face of east parapet at light pole between Piers 1 and 2.

PHOTO 5 - CONDITION OF PARAPET AND EXPANSION JOINT AT WEST END OF PIER 4.

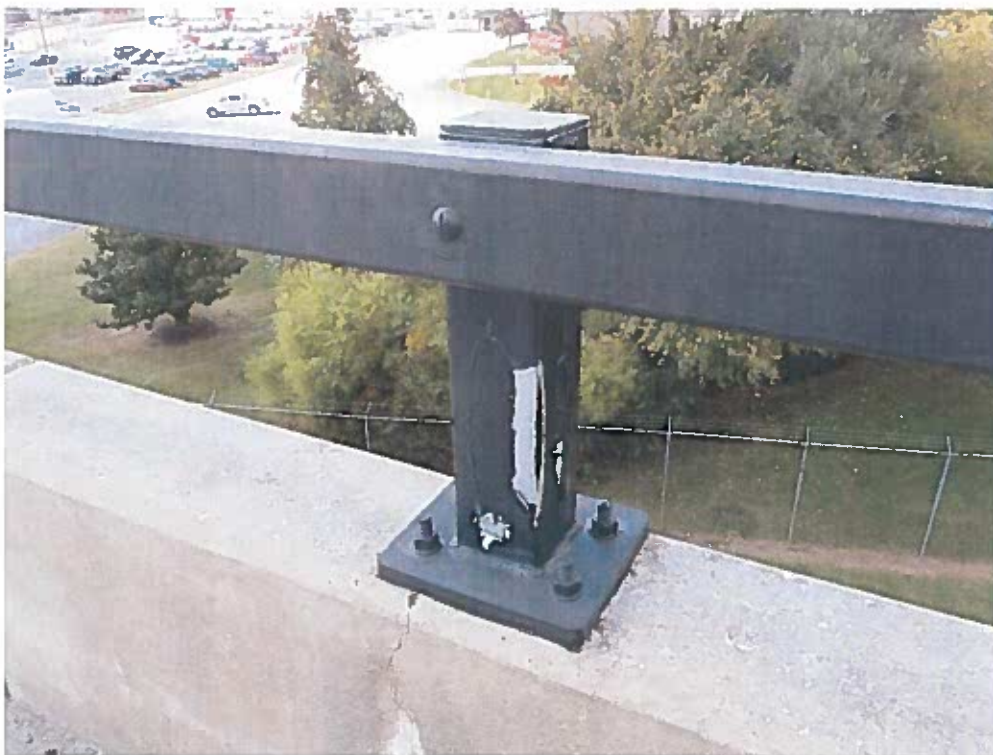
Paint is peeling throughout both railings (Photo 6). Rail posts exhibit splitting (up to 1/4" wide) longitudinal to the post axis (Photo 6): 11 in east railing, 16 in west railing.

PHOTO 6 - TYPICAL SPLIT IN RAIL POST.

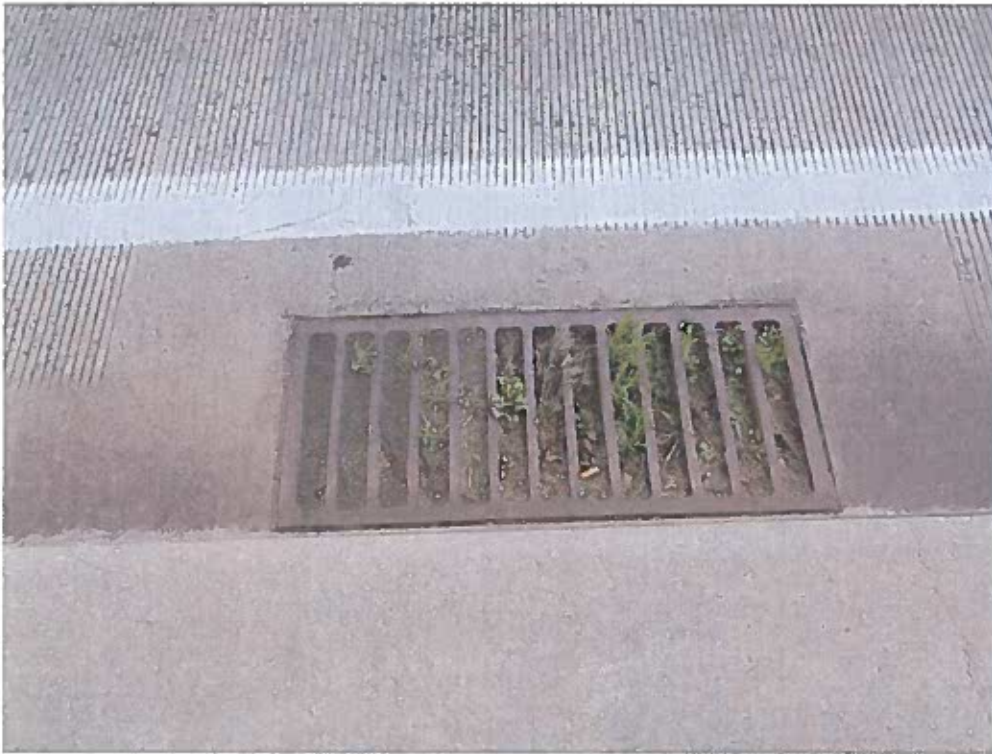
Majority of drain grates are clogged (up to 100%) with dirt and debris (Photo 7). Several hangers for pipes are bent in each span. Active and evidence of past water leakage at Pier 2 (east drain), Pier 4 (west drain) (Photo 8), and Pier 5 (west drain).

PHOTO 7 - TYPICAL CLOGGED DRAIN GRATE.

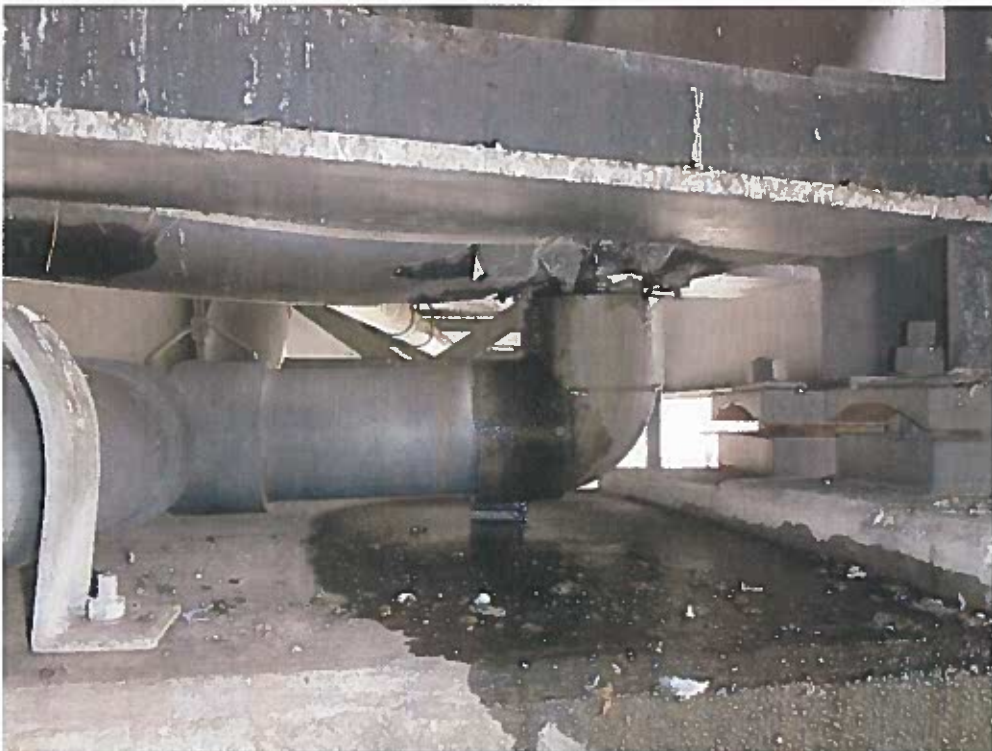
PHOTO 8 - CONDITION OF EXPANSION JOINT TROUGH AT WEST END OF PIER 4.

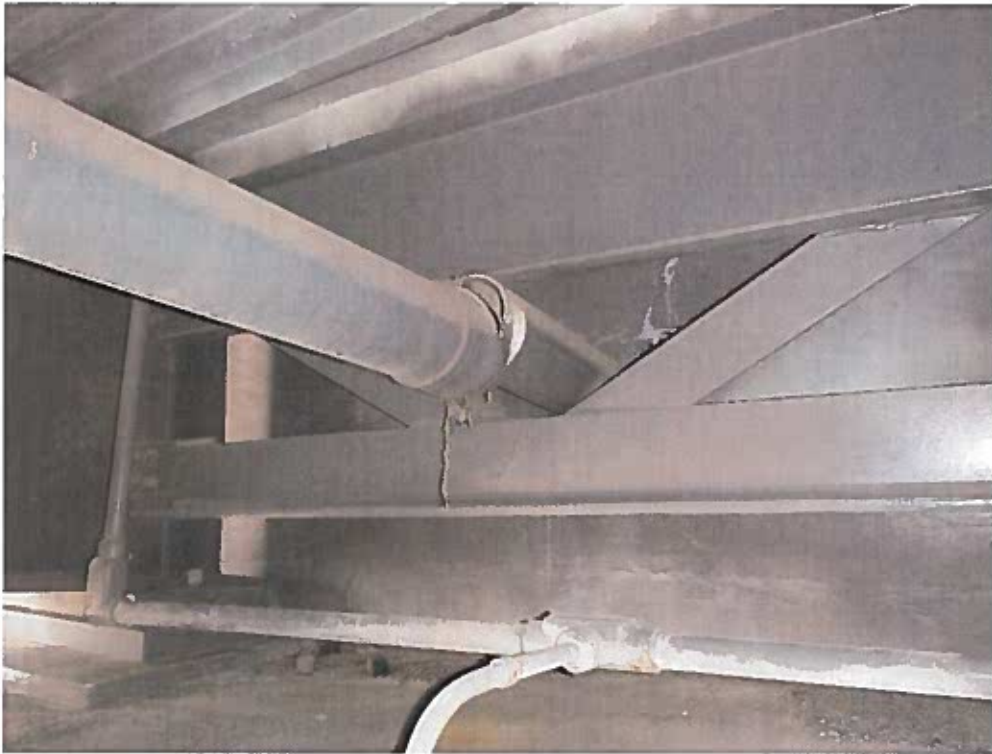
Disconnected fitting for east drain pipe adjacent to Abutment A (Photo 9).

PHOTO 9 - SEPARATED COUPLING FOR EAST DRAIN PIPE AT ABUTMENT A.

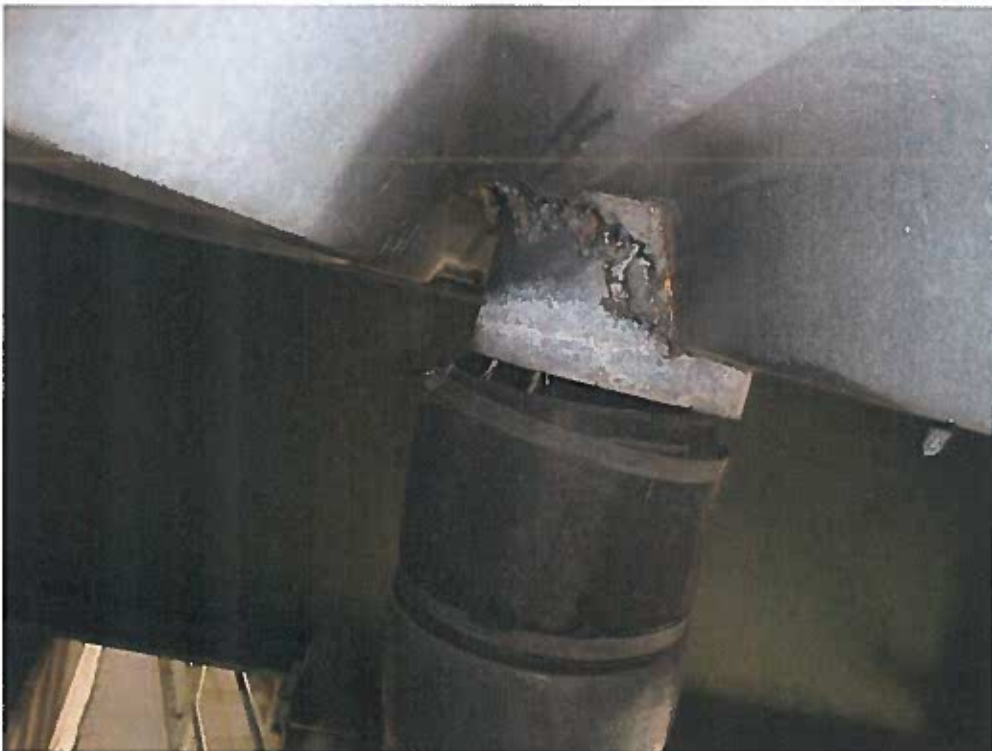
PHOTO 10 - SEPARATED RUBBER COUPLING FOR WEST DRAIN PIPE IN SPAN 6 AT ABUTMENT B.

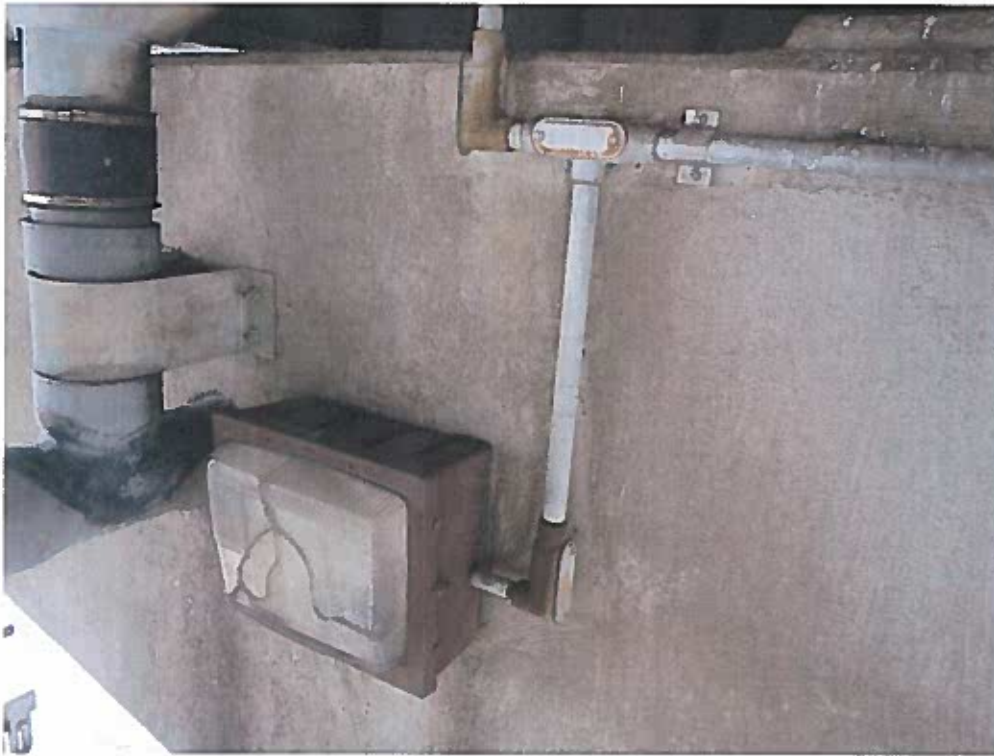
PHOTO 11 - CRACKED LENS FOR LIGHT ATTACHED TO PIER 2. NOTE RUST ON CONDUIT.

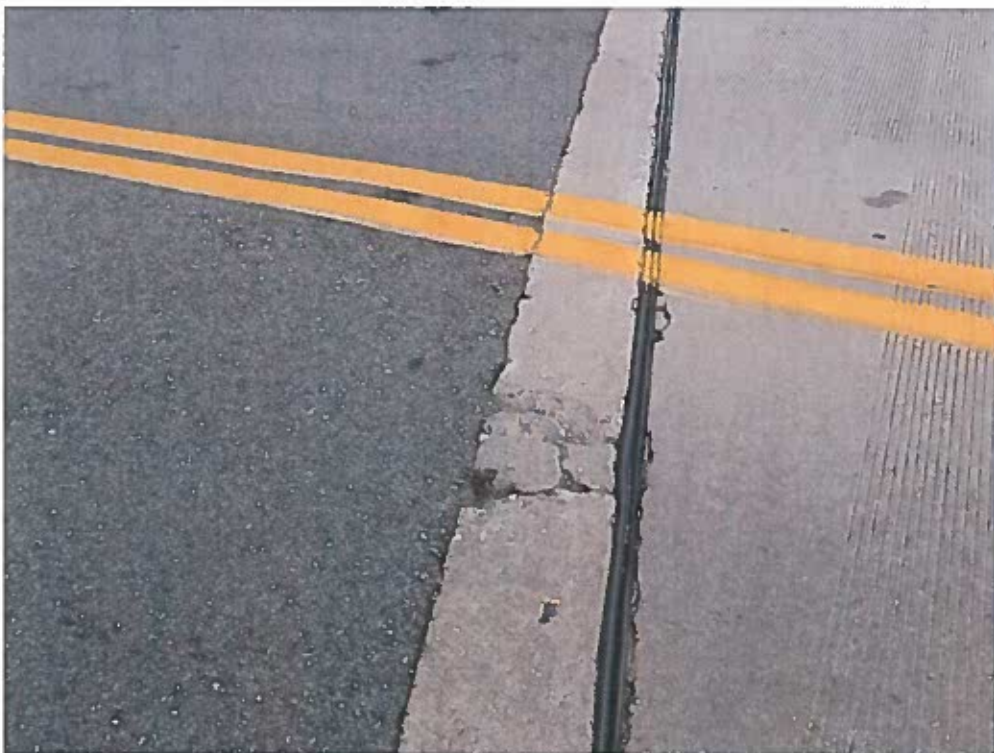
PHOTO 12 - SPALL/DELAMINATION IN TOP OF ABUTMENT B BACKWALL.

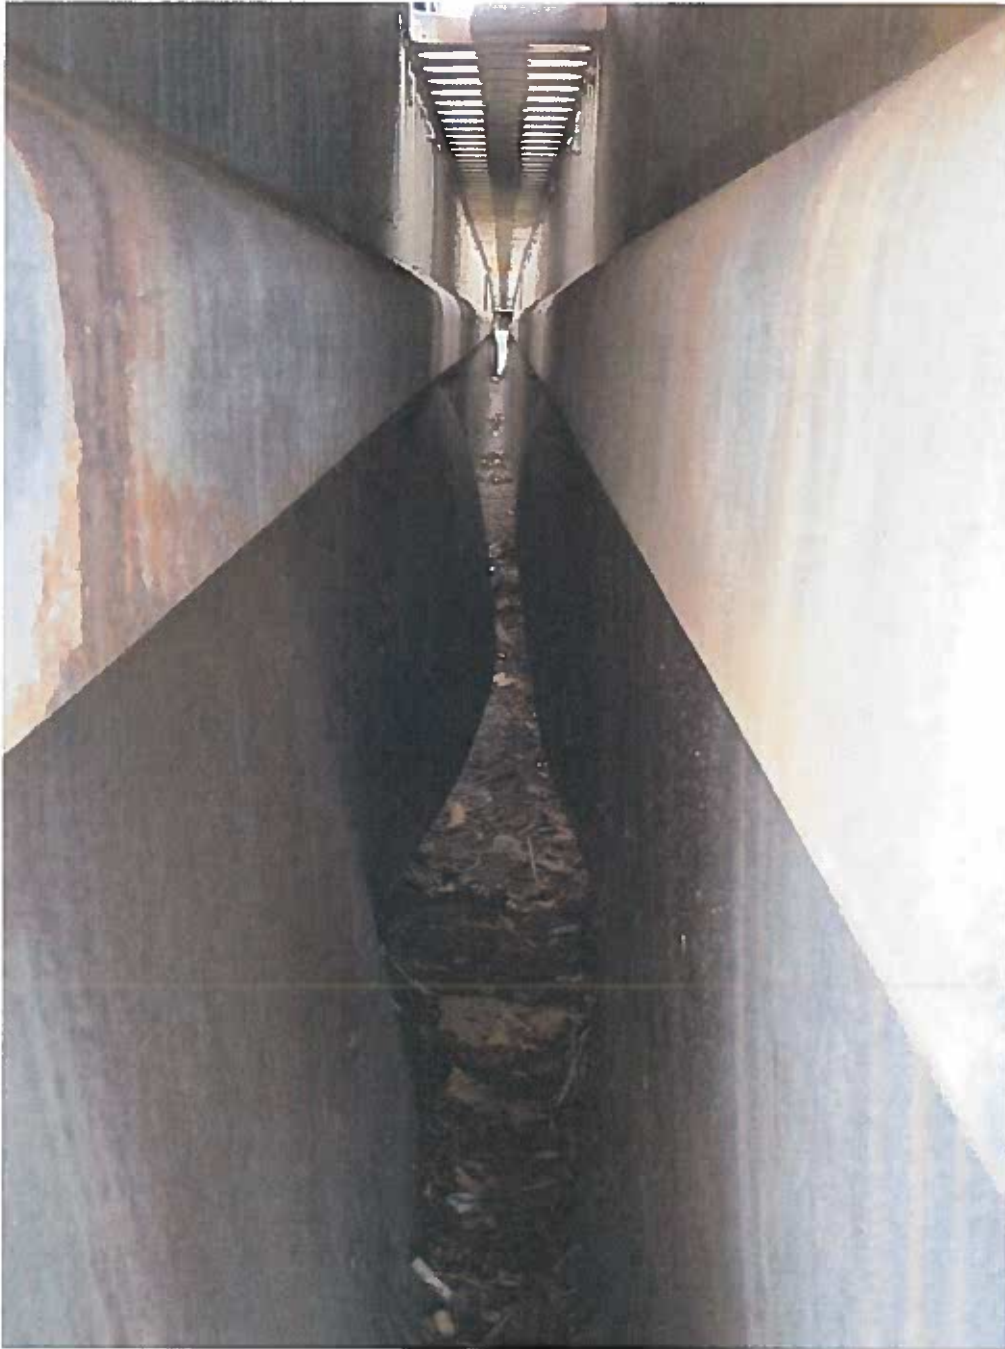
<u>Utilities</u>	Two 4" utility conduits between Girders 3 and 4 in Span 2. Several hangers are bent.
<u>Expansion Joints</u>	<u>Preformed Elastomeric Joints</u>	At both abutments. Light dirt and debris in joints at both abutments (Photo 12). One small split (less than 6" long) in joint material near west end of Abutment B.
	<u>Tooth Expansion Joint</u>	At Pier 4. South side of joint has separated (up to 1") from adjacent concrete on west end of structure (Photo 5). Heavy dirt and debris in trough has clogged the collection system at both ends of pier (Photos 8 & 13).

PHOTO 13 - DIRT AND DEBRIS IN PIER 4 EXPANSION JOINT TROUGH.

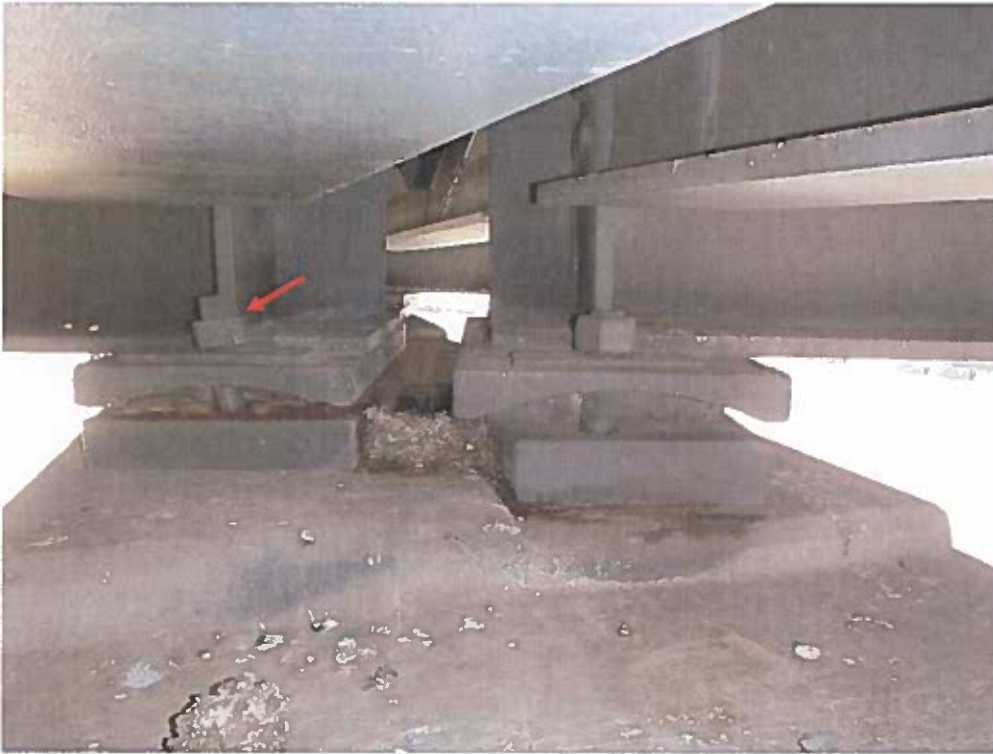
SUPERSTRUCTURE	GENERAL CONDITION RATING	7
<u>Bearing Devices</u>	Light surface rust on most bearing devices, primarily under expansion joints (Photo 14). Anchor bolts do not extend past top of nut at several locations throughout the structure. Anchor bolts for girders in Span 5 at Pier 4 are bent slightly to the north (worst at Girder 4) (Photo 14). Loose anchor bolt nuts noted throughout as follows (Photo 15):	
	<u>Abutment A</u>	<u>Pier 3</u>
	Girder 1 - 1	Girder 4 - 1
	Girder 3 - 2	Girder 5 - 1
	Girder 4 - 1	Girder 6 - 1
	Girder 5 - 2	
	Girder 7 - 1	<u>Pier 4</u>
		Girder 3 - 2 (1 noted during previous inspection)
	<u>Pier 1</u>	Girder 5 - 1
	Girder 2 - 1	Girder 7 - 1
	Girder 3 - 1	
	Girder 4 - 1	<u>Pier 5</u>
	Girder 7 - 1	Girder 4 - 1
	<u>Pier 2</u>	
	Girder 2 - 2	
	Girder 3 - 1	
	Girder 4 - 1

PHOTO 14 - TYPICAL RUST ON BEARINGS UNDER EXPANSION JOINT. NOTE BENT ANCHOR BOLT.

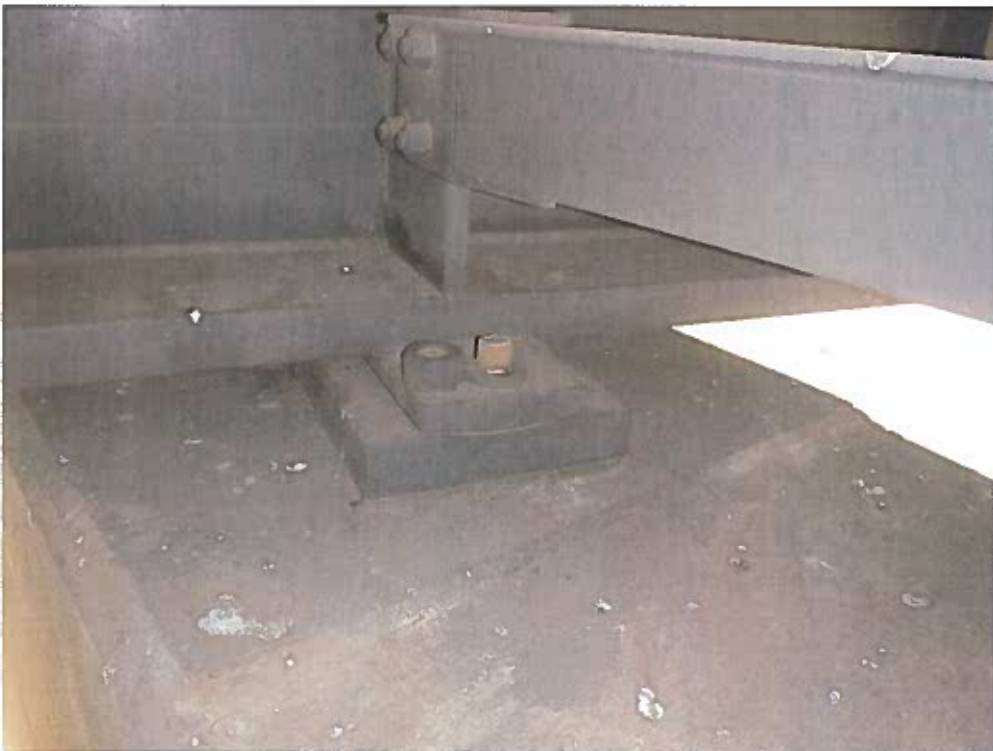
PHOTO 15 - TYPICAL LOOSE ANCHOR BOLT NUT.

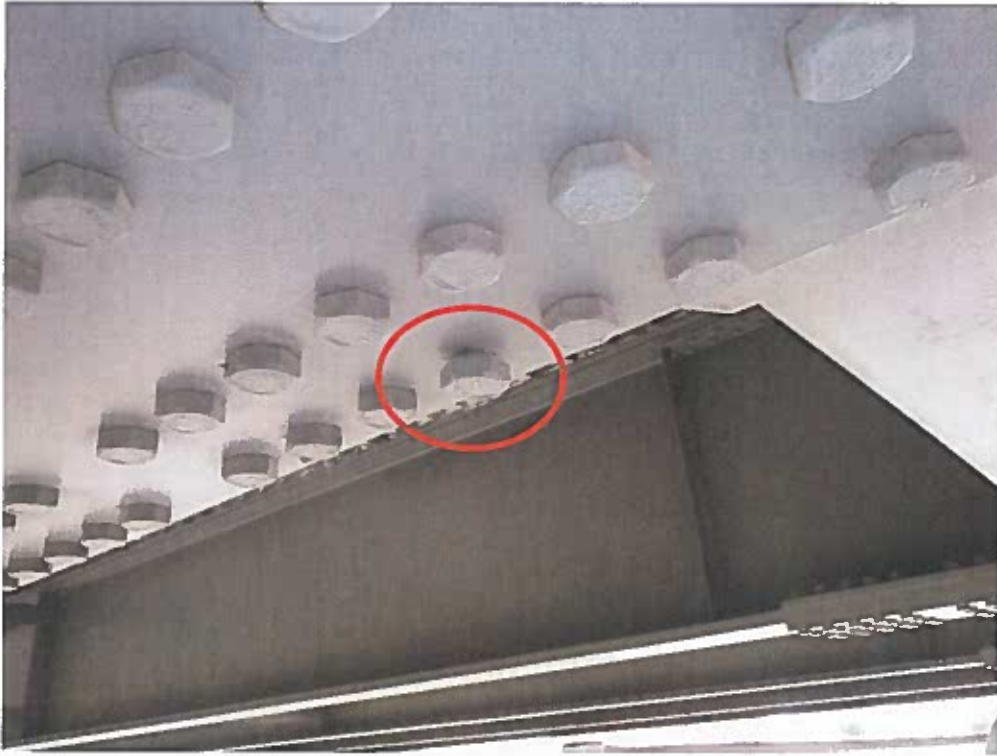
PHOTO 16 - LOOSE BOLT IN BOTTOM FLANGE SPLICE FOR GIRDER 3 IN SPAN 6.

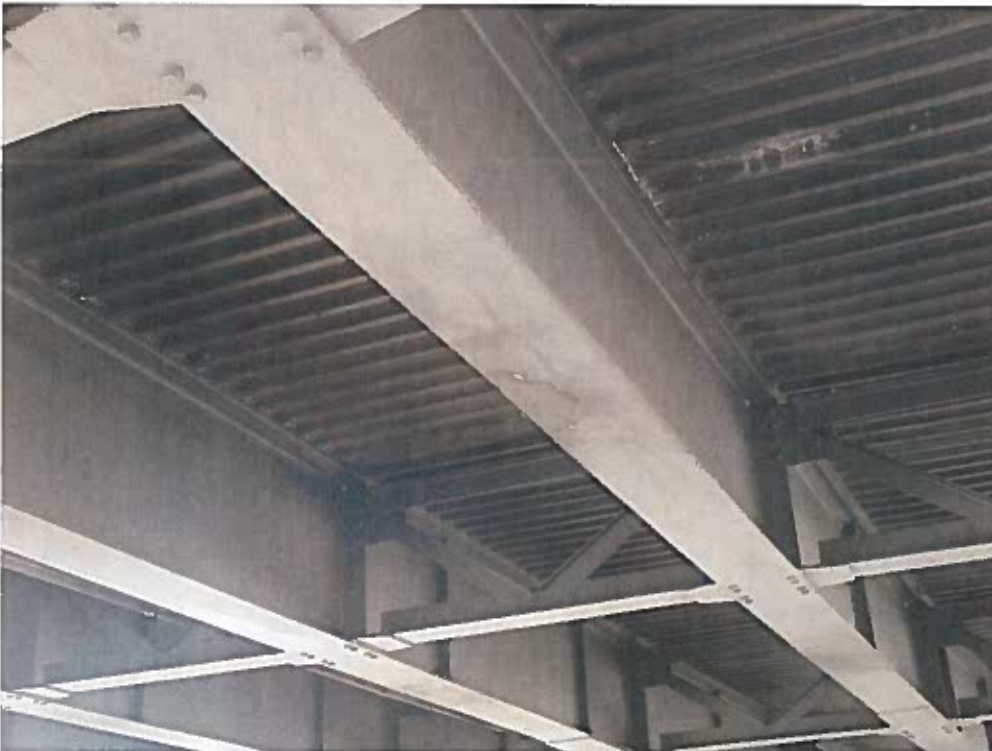
PAINT	Year painted – 1997. Peeling on Girder 5 in Span 2, near mid-span (Photo 17). Flaking at Girder 6 bearing, Pier 4, north side.

PHOTO 17 - PAINT PEELING ON GIRDER 5 IN SPAN 2.

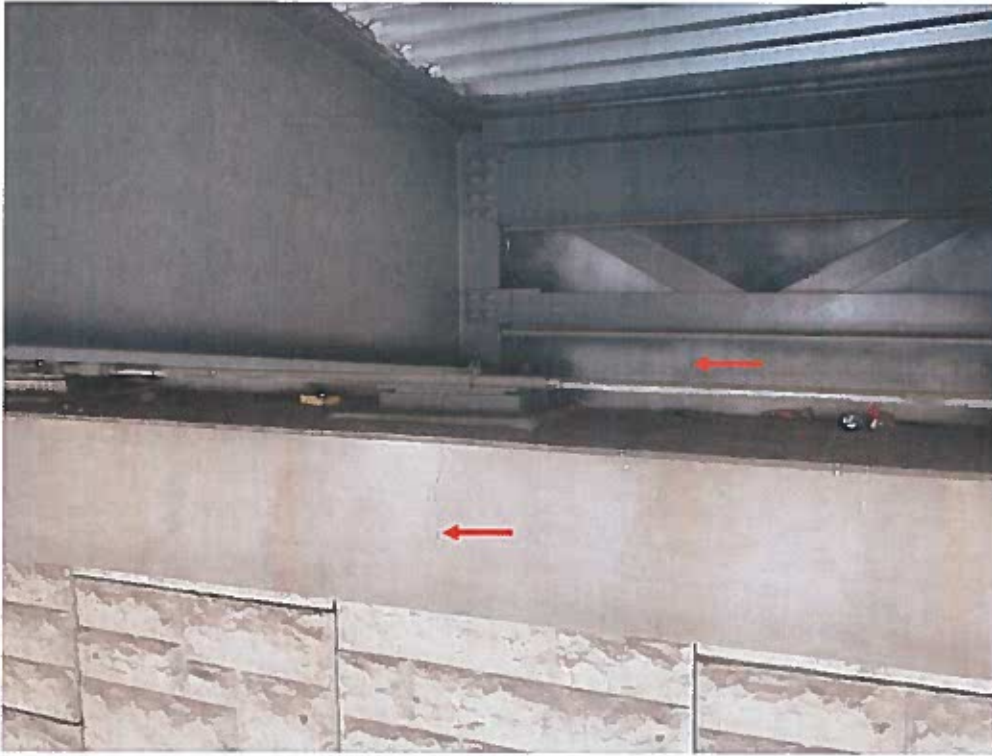
SUBSTRUCTURE	GENERAL CONDITION RATING 7
ABUTMENTS	
<u>Wingwalls</u>	No deficiencies noted. MSE construction.
<u>Backwalls</u>	<u>Abutment A</u> 24 full width hairline cracks in top of backwall. Light chipping (up to 1/2" deep) in top of backwall. 9 full height vertical hairline cracks in face of backwall (Photo 18). <u>Abutment B</u> 1 SF spall/delamination (up to 2-1/2" deep) in top of backwall in left southbound lane (Photo 12). 19 full width hairline cracks in top of backwall. Light chipping (up to 1/2" deep) in top of backwall. 11 full height vertical hairline cracks in face of backwall.
<u>Bearing Seats</u>	Light dirt and debris on all bearing seats.
<u>Breastwalls</u>	Light dirt and debris on top of both breastwalls. <u>Abutment A</u> 9 full height vertical hairline cracks in MSE wall coping (Photo 18). 3 full width horizontal hairline cracks in east corner coping (post). 1 full width horizontal hairline crack in west corner coping (post). <u>Abutment B</u> 17 full height vertical hairline cracks in MSE wall coping. Two horizontal hairline cracks in east corner coping (post). Two horizontal hairline cracks in west corner coping (post).

PHOTO 18 - TYPICAL VERTICAL CRACKS IN ABUTMENT BACKWALL AND COPING.

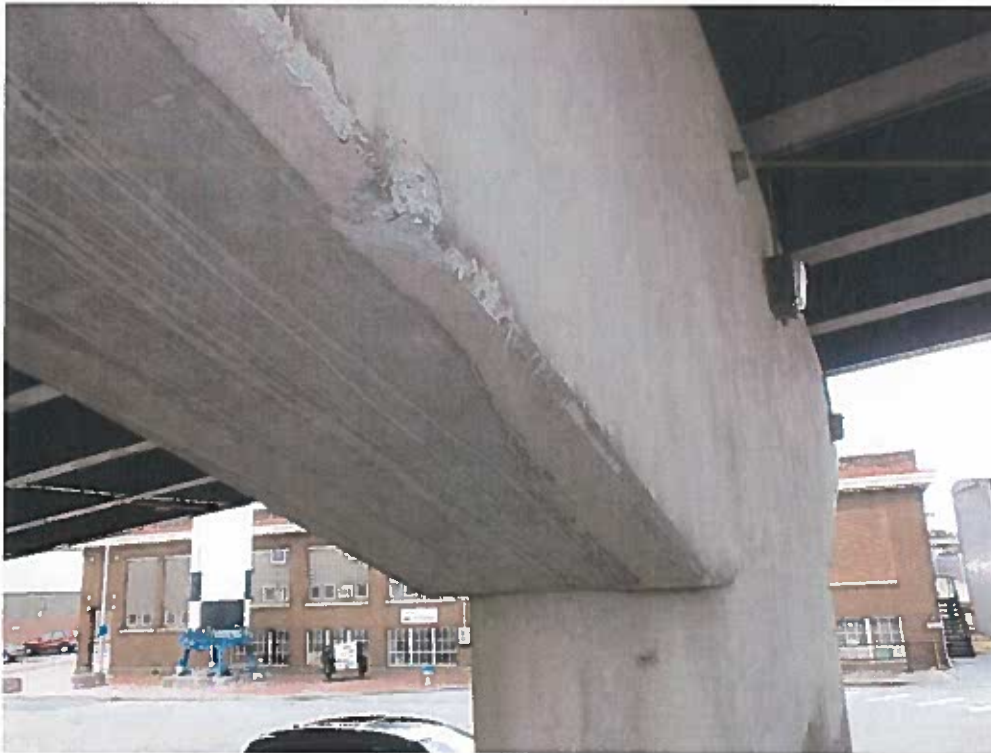
PIERS	<u>Caps</u>	Light hairline cracks on top of all pier caps. Light vertical hairline cracks in faces of all pier caps. <u>Pier 1</u> 0.5 SF spall (up to 2" deep) in underside of east arm, Span 2 side (Photo 19). <u>Pier 2</u> 0.5 SF spall (up to 2" deep) in east end at top. Exposed reinforcing steel in underside of east arm due to lack of cover. <u>Pier 4</u> Active and evidence of past water leakage from expansion joint trough at both ends of cap (Photo 8). 1 LF vertical hairline crack under west drain pipe. <u>Pier 5</u> 1 LF vertical hairline crack under west drain pipe.
	<u>Bearing Seats</u>	Light dirt and debris on all bearing seats. Light hairline cracks across tops of bearing seats.
	<u>Stems</u>	<u>Pier 1</u> Light vertical hairline cracking and map cracking on both faces. 0.5 SF of spall (up to 1" deep) with exposed reinforcing steel in east radius. <u>Pier 4</u> Light map cracking at both ends.

PHOTO 19 - SPALLS IN PIER 1 CAP AND STEM.

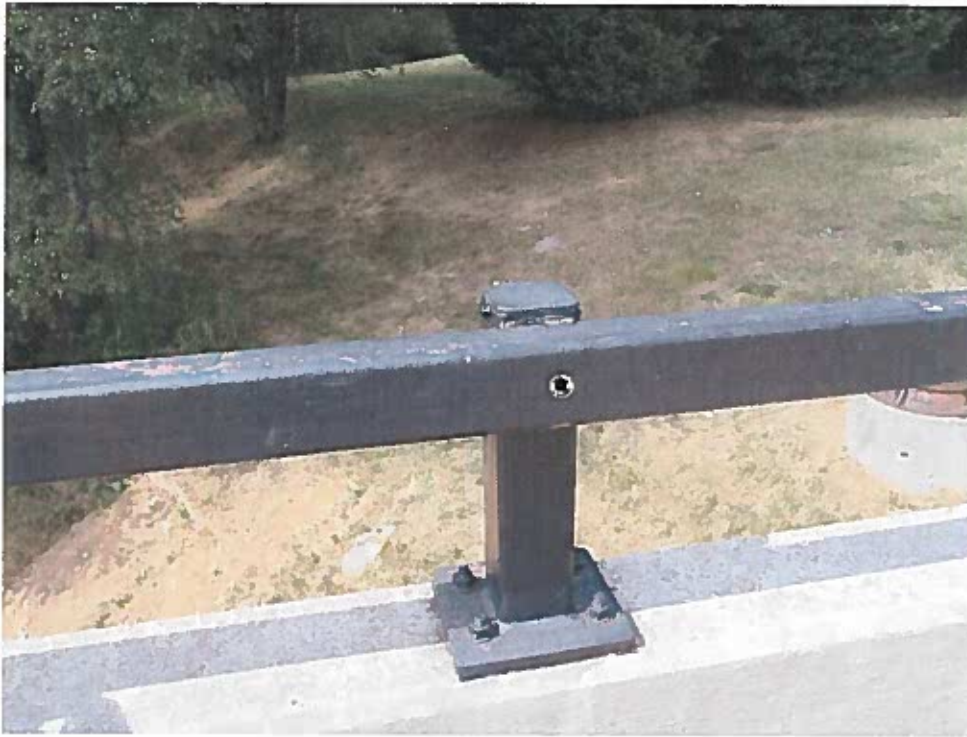
PHOTO 20 - MISSING CONNECTION BOLT FOR WEST APPROACH RAILING NEAR ABUTMENT B.

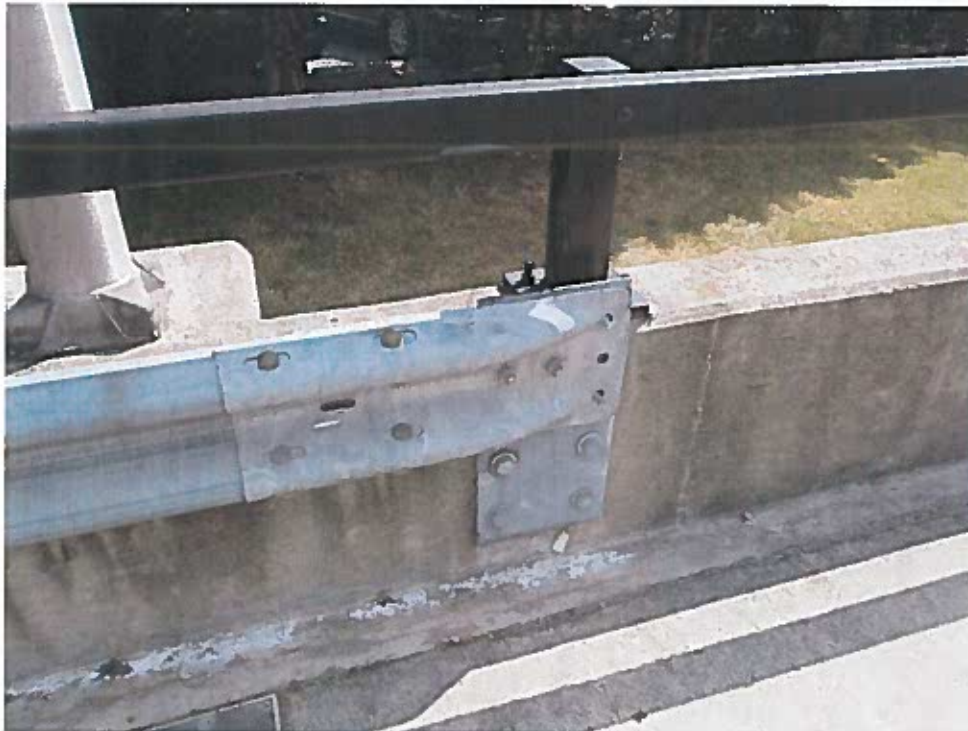
PHOTO 21 - MISSING NUTS FOR GUARDRAIL ANCHORAGE TO EAST APPROACH PARAPET AT ABUTMENT B.
